# IGNIS INDICATIVE TESTING

## C-COAT

IGNL-5103-04R Issue 01 Revision 00 [2021]

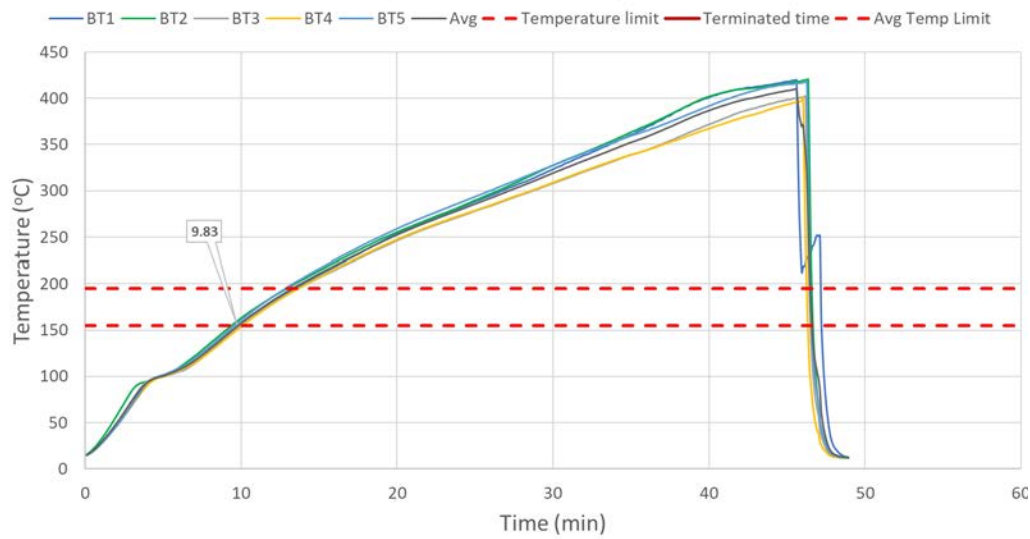
**FIGURE 3:**  
THERMOCOUPLE TEMPERATURES (THERMOCOUPLES WERE REMOVED AFTER 46MINS TO AVOID DAMAGES)

<b>TEST METHOD:</b>	The constructed wall specimen system was tested in accordance with Australian Standard 1530 Methods for fire tests on building materials, components and structures, Part 4: Fire-resistance tests for elements of construction.
<b>OBSERVATIONS:</b>	9:83      The average temperature of the specimen thermocouples exceeded the permissible limit of 140 °C above the initial temperature.

20:00	Smoke was observed emitting from the panel edge.
30:00	Charring was observed at the specimen edges.
46:00	Thermocouples were removed after 46mins to avoid damages.
50:00	Charring area expanded and covered the most of the specimen and the FC panels around the specimen.
58:37	Crack was observed in the middle of the specimen.
79:00	FC at the left corner around the specimens cracked.
80:00	Cotton pad was applied to the crack of the specimen and ignition was observed.
85:00	Test stopped.

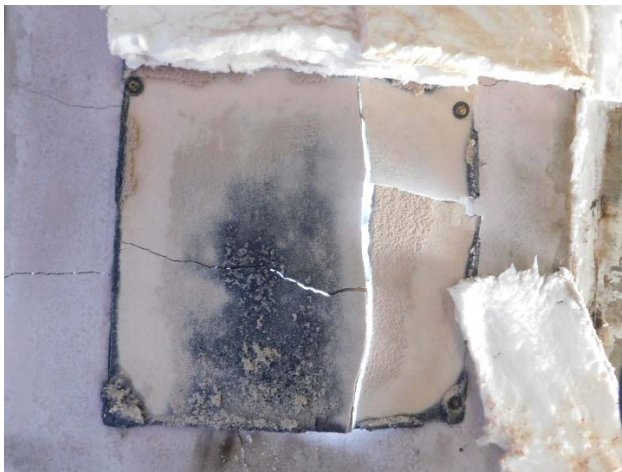
FIGURE 6:

SPECIMEN AFTER TEST (FIRE EXPOSED SIDE)

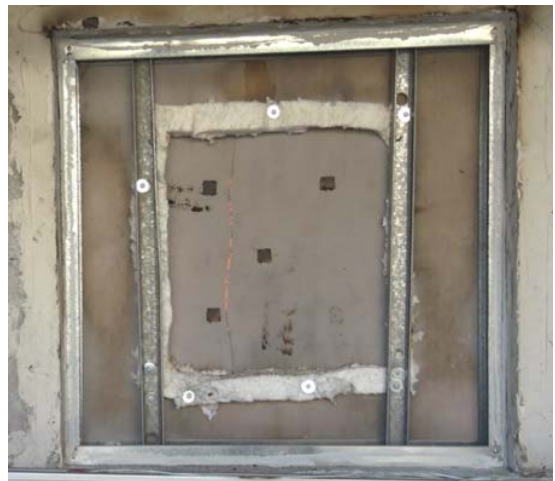
SPECIMEN AFTER TEST (FIRE NON-EXPOSED SIDE)
