**C-Coat IC-Grey**

**TEST REPORT  
AS 1530.4:2014**

IGNL-6093-04-01R I01 R00

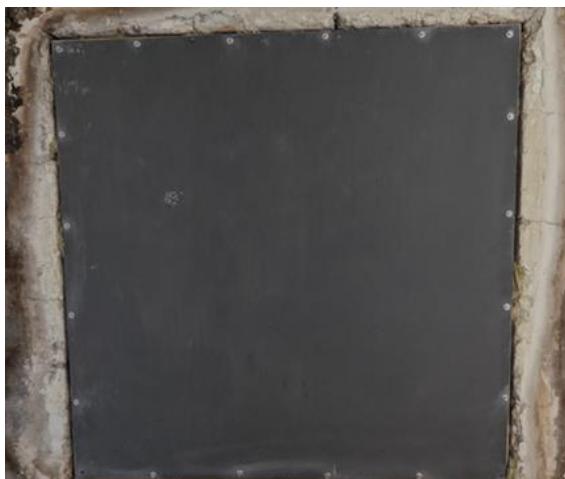
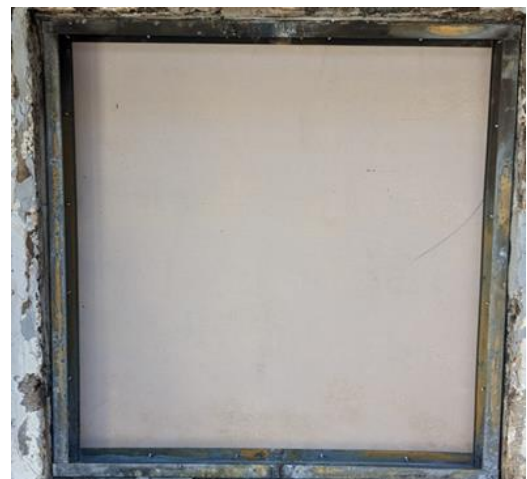
FIGURE 1:

The layers of the specimen were fixed to the 92 mm wide galvanised steel test frame using 45 mm hex head screws at 200 mm spacings. The C-Coat IC Grey was applied to the C-Coat NFS insulation as a liquid in layers of approximately 1 mm.

EXPOSED FACE OF SPECIMEN

UNEXPOSED FACE OF SPECIMEN

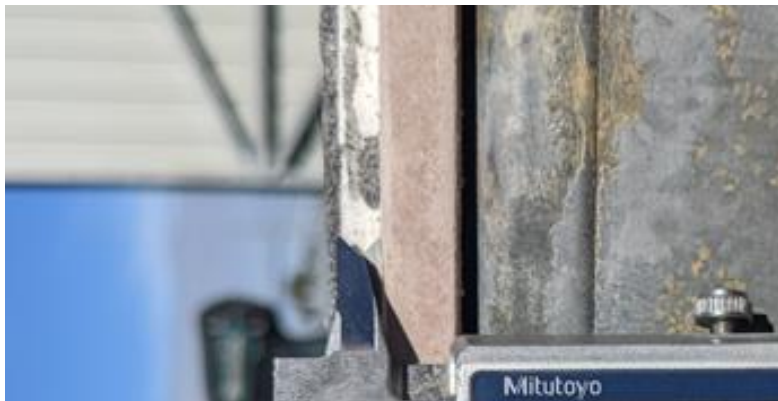
FIGURE 2:

The layers of the specimen were fixed to the 92 mm wide galvanised steel test frame using 45 mm hex head screws at 200 mm spacings. The C-Coat IC Grey was applied to the C-Coat NFS insulation as a liquid in layers of approximately 1 mm.

A cross section of the specimen is shown below.

SPECIMEN CROSS-SECTION

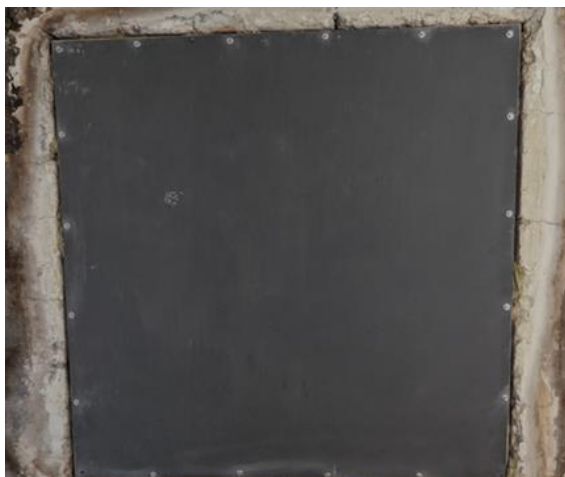
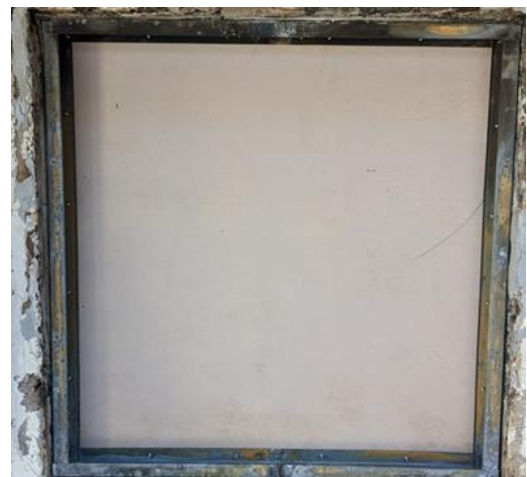
FIGURE 3:

EXPOSED FACE OF SPECIMEN

UNEXPOSED FACE OF SPECIMEN

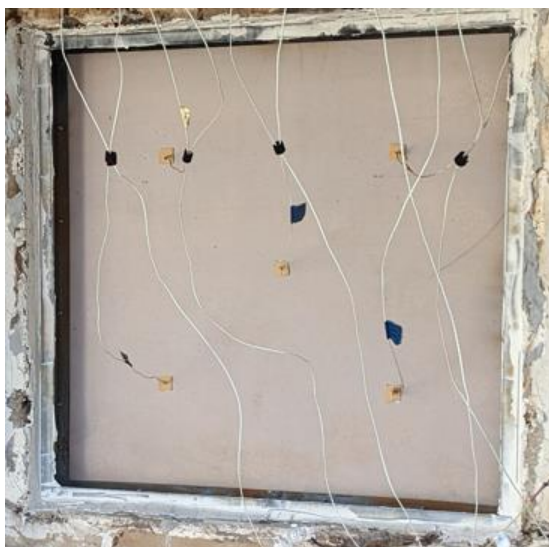
FIGURE 6:

SPECIMEN 40 MIN INTO THE TEST (UN-EXPOSED FACE)

SPECIMEN 60 MIN INTO THE TEST (UN-EXPOSED FACE)

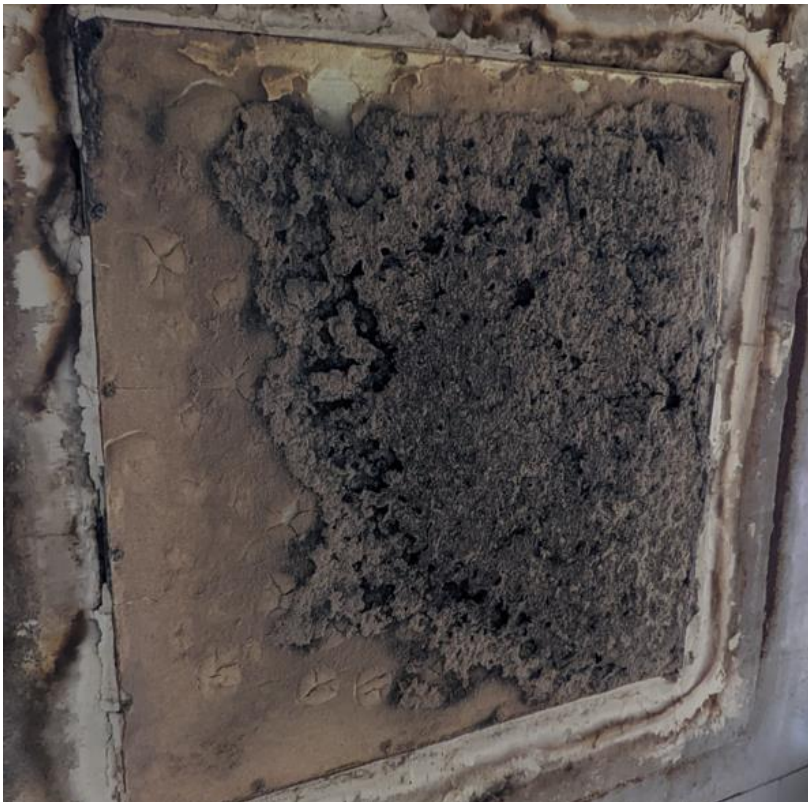
FIGURE 8:

POST TEST SPECIMEN (EXPOSED FACE)

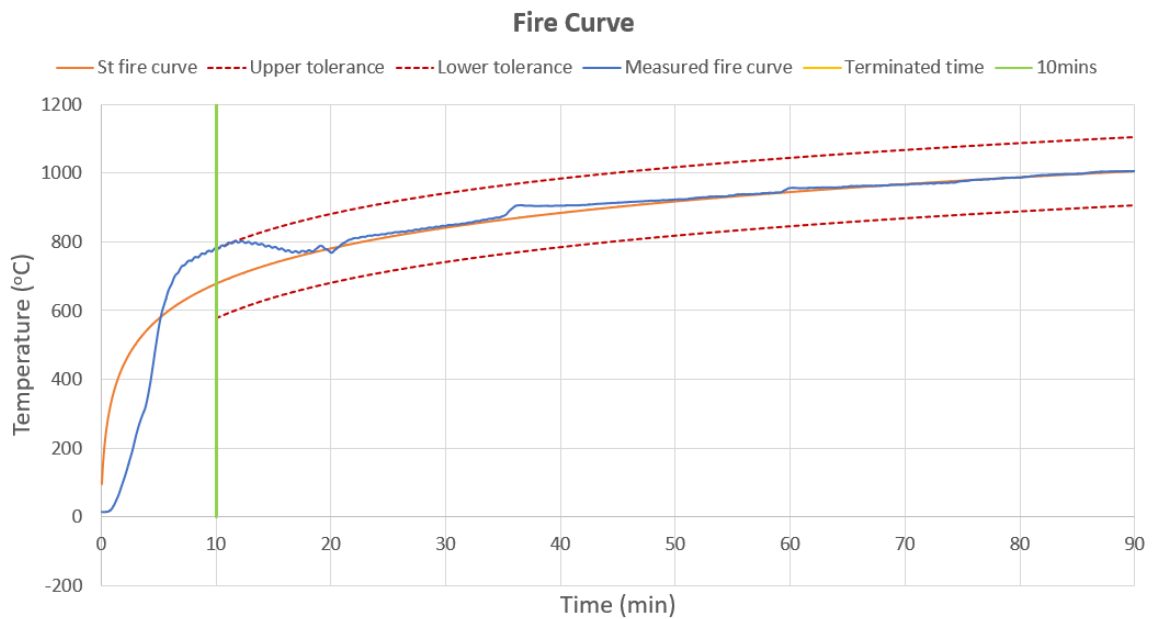
FIGURE 9:

The following figure shows the standard curves of temperature versus time for heating the furnace chamber and the actual curves of the average temperature and the tolerance limits. Despite being in line with the upper tolerance for the first two minutes of the test, the furnace temperature follows the standard fire curve within the range of tolerances during the whole test.

TEST FURNACE TEMPERATURES

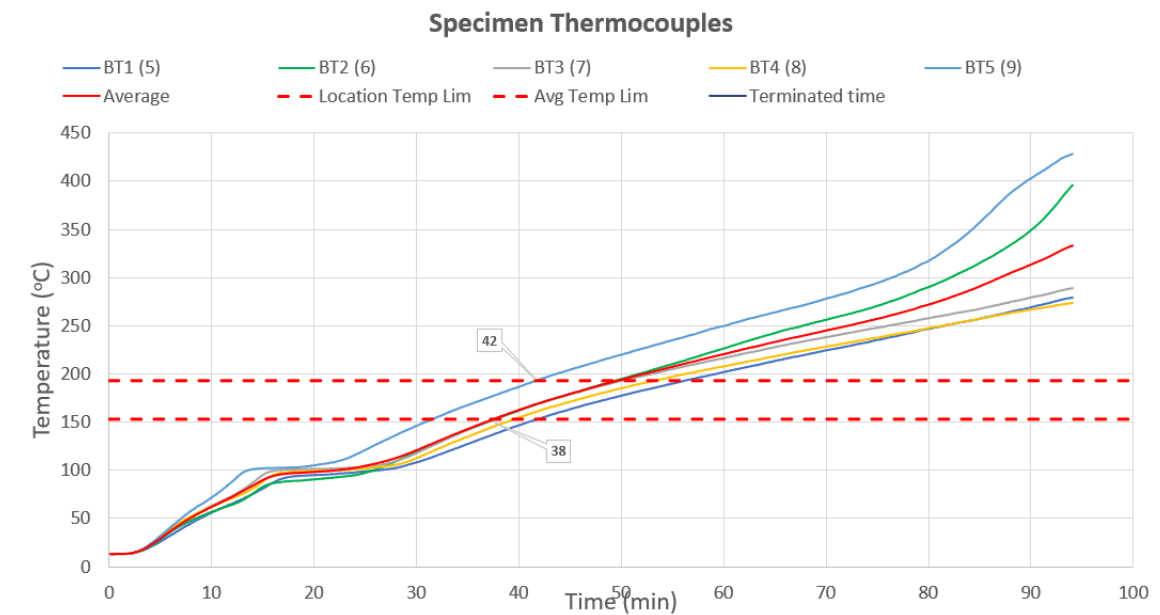
FIGURE 11:

The specimen temperature was monitored by five baseline thermocouples as shown in Figure 4. The specimen temperature at five locations of each panel is shown in the graphs below.

All thermocouples on the un-exposed face of the specimen exceeded the permissible limit of 180 K above the initial temperature and the average baseline temperature exceeded the permissible limit of 140 K above the initial temperature at 42 and 39 minutes into the test respectively.

UN-EXPOSED FACE BASELINE TEMPERATURES
