NANOTECHNOLOGIC
MICRO-COATING SYSTEM

THERMAL INSULATING TREATMENT REPORT

The measurements in this report were conducted in the month of August and concern the trend of the external temperatures of the roof and walls of a residential structure facing the sea located in the marina of Sorso (SS) before during and after the application of the nanotechnological microcapping C-COAT Facade.

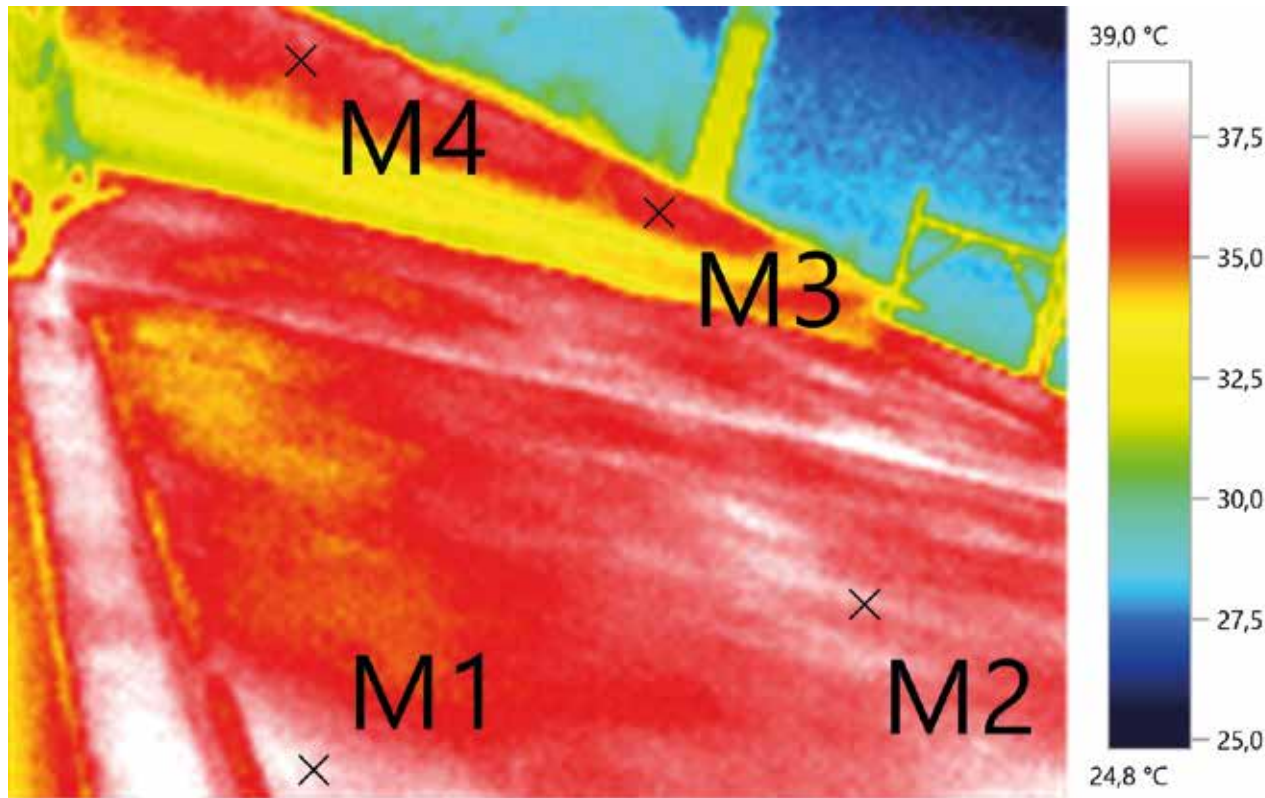
Img 0. Roof surface, thermal detection.

N.	Temp. [°C]
M1	38,0
M2	37,2
M3	35,6
M4	36,0

Temperature ratings Img 0.

The roof surface is a rough concrete screed. The surface temperatures are between or 35 and 40 degrees before the start of the intervention.

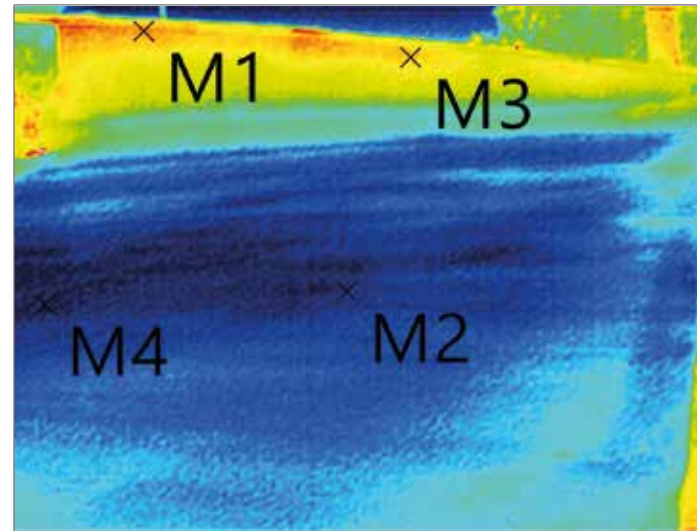
Img 2. Roof surface, thermal survey.

N.	Temp. [°C]
M1	33,6
M2	23,9
M3	32,8
M4	23,8

Temperature ratings Img 2.

It is noteworthy that already after the application of a layer of only **0.5 mm**, the first visible results emerged. However, the performance does not yet show complete homogeneity.

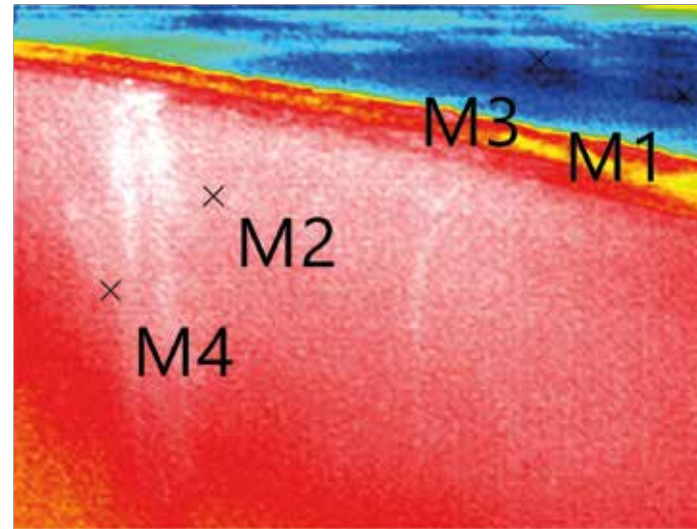
Img 4. North wall surface and roof surface, thermal survey.

N.	Temp. [°C]
M1	24,4
M2	34,0
M3	24,8
M4	33,5

Temperature ratings Img 4.

In this survey, the difference in temperature between two surfaces exposed to the same degree of solar irradiation can be seen most clearly. M4 and M2 refer to the north wall, which has not yet been treated; M1 and M3 refer to the roof surface: **only treated with 0.5 mm for the time being.**

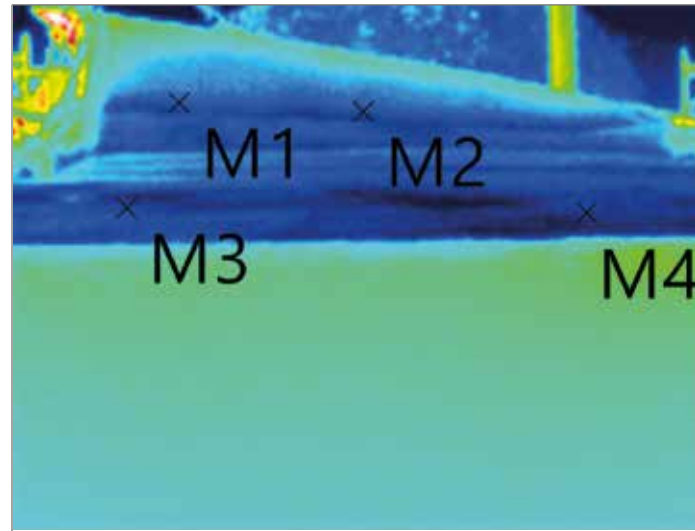
Img 6. East wall surface and roof surface, thermal survey.

N.	Temp. [°C]
M1	28,1
M2	28,0
M3	28,0
M4	27,2

Temperature ratings Img 6.

Having reached a thickness of 1.00 mm, all treated surfaces reached homogeneity in a stable temperature of around 30 degrees the day after the application ended.

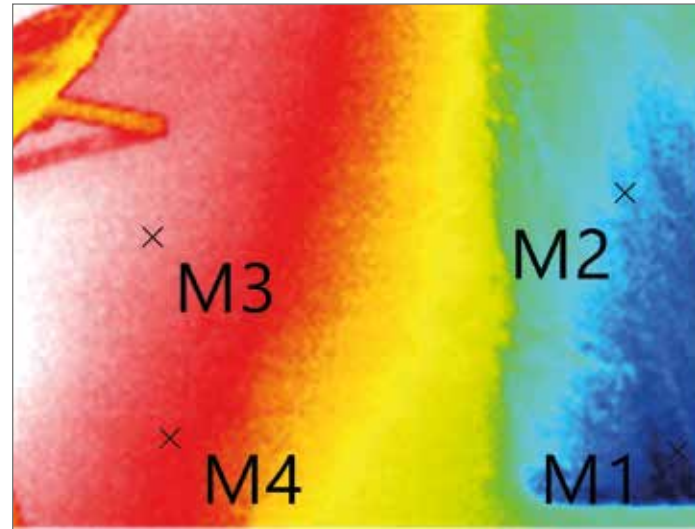
Img 8. South wall surface of adjacent building (untreated) and East wall (treated building) thermal survey.

N.	Temp. [°C]
M1	29,0
M2	30,8
M3	41,0
M4	39,7

Temperature ratings Img 8.

After application, we can clearly see the difference between an untreated surface and the surface treated with 1.00 mm of nanocoat, both exposed to the same degree of solar radiation.

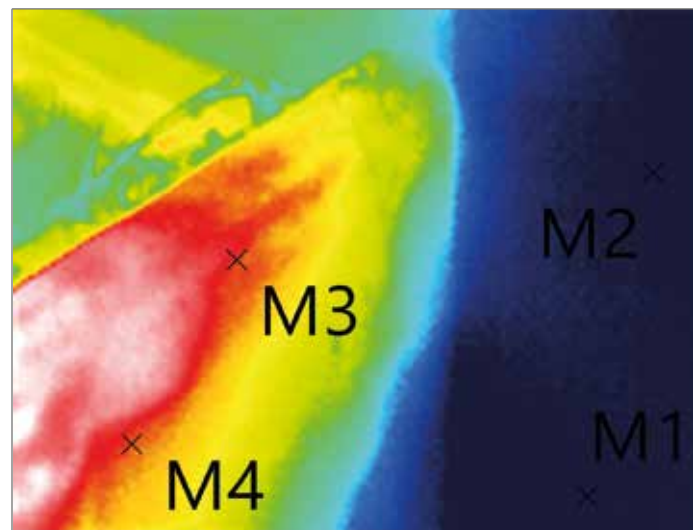
Img 10. Comparison of treated and untreated surface area on the south side of the building, thermal survey.

N.	Temp. [°C]
M1	33,3
M2	33,4
M3	47,2
M4	46,8

Worthy of note are the comparison values between a wall treated with 1.00 mm thickness and a wall treated with tar paper (the C-Coat FACADE is perfectly impermeable to water and vapour-breathable).

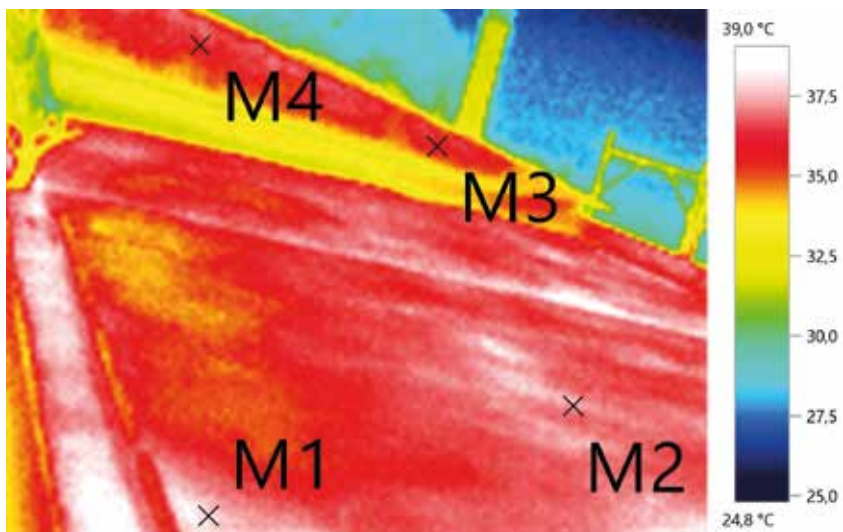
Img 11. Roof surface, thermal survey PRE-INTERVENTION

N.	Temp. [°C]
M1	38,0
M2	37,2
M3	35,6
M4	36,0

Temperature ratings Img 11.

At the end of the job, once the microcoat has dried completely, comparisons between PRE and POST intervention show a thermal gap of about 10 degrees on the surface temperatures of the roof.

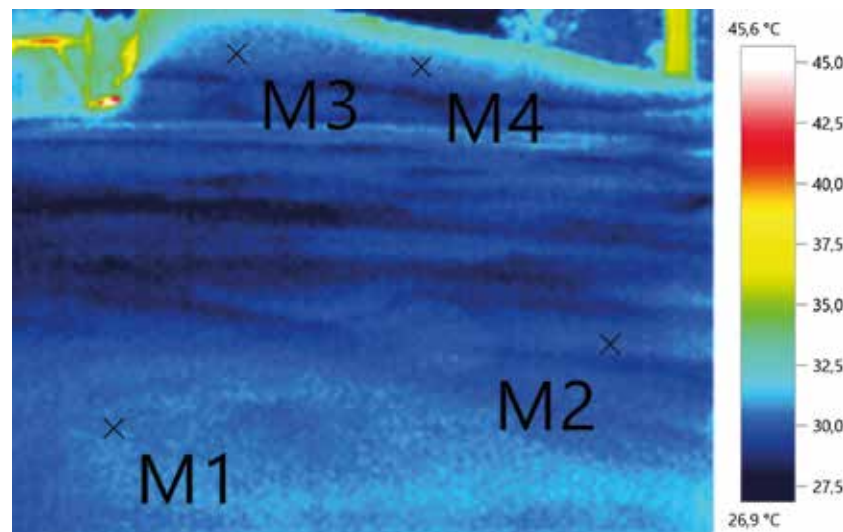
Img 12. Roof surface, POST-INTERVENTION thermal survey.

N.	Temp. [°C]
M1	28,2
M2	28,5
M3	28,3
M4	28,5

Temperature ratings Img 12.
