ACRYLIC TECHNOLOGIES AUSTRALIA

C-COAT TEMPERATURE TESTING

REF: TIATA002

Trackie Industries recently carried out temperature data logging to review the performance of C-Coat surface applied thermal coating.

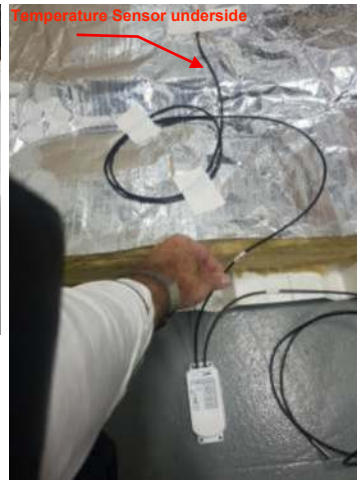
Roof with 130mm insulation R3.0

Sensors were positioned on top of the roofs and directly underneath.

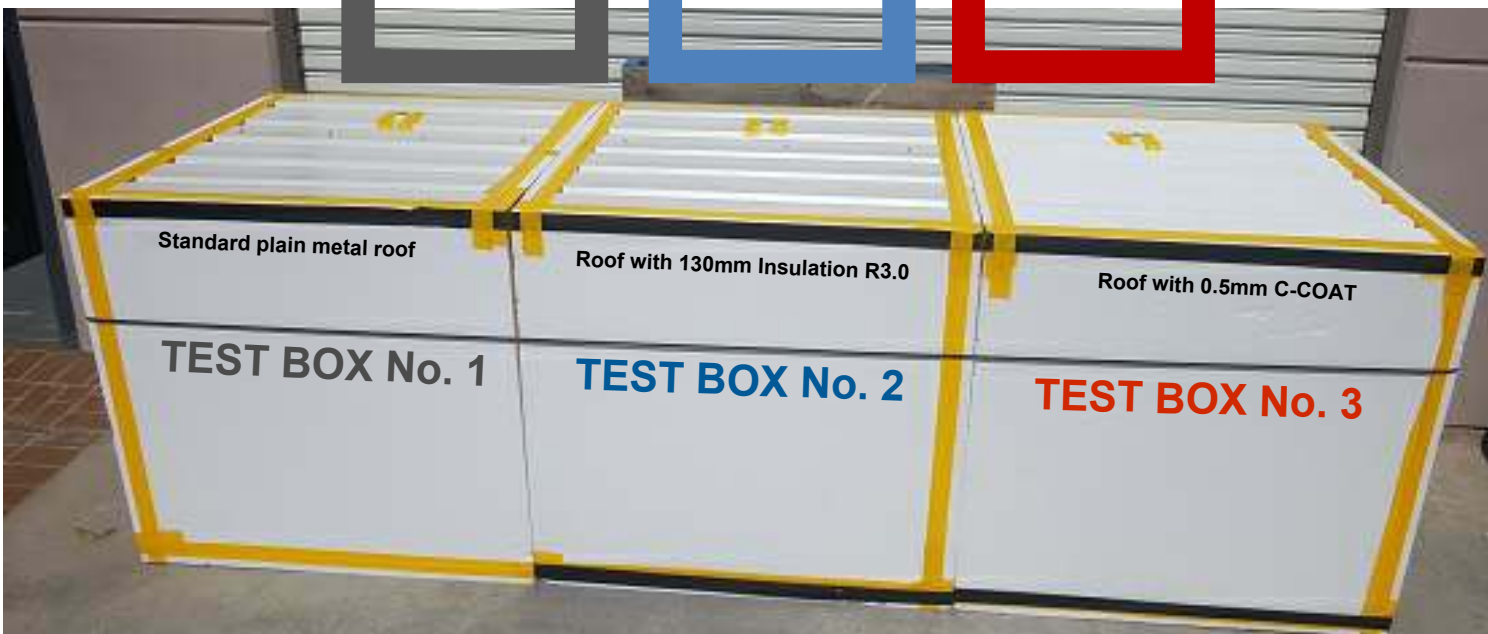
Graphic symbols used to represent individual Test Boxes in graphs

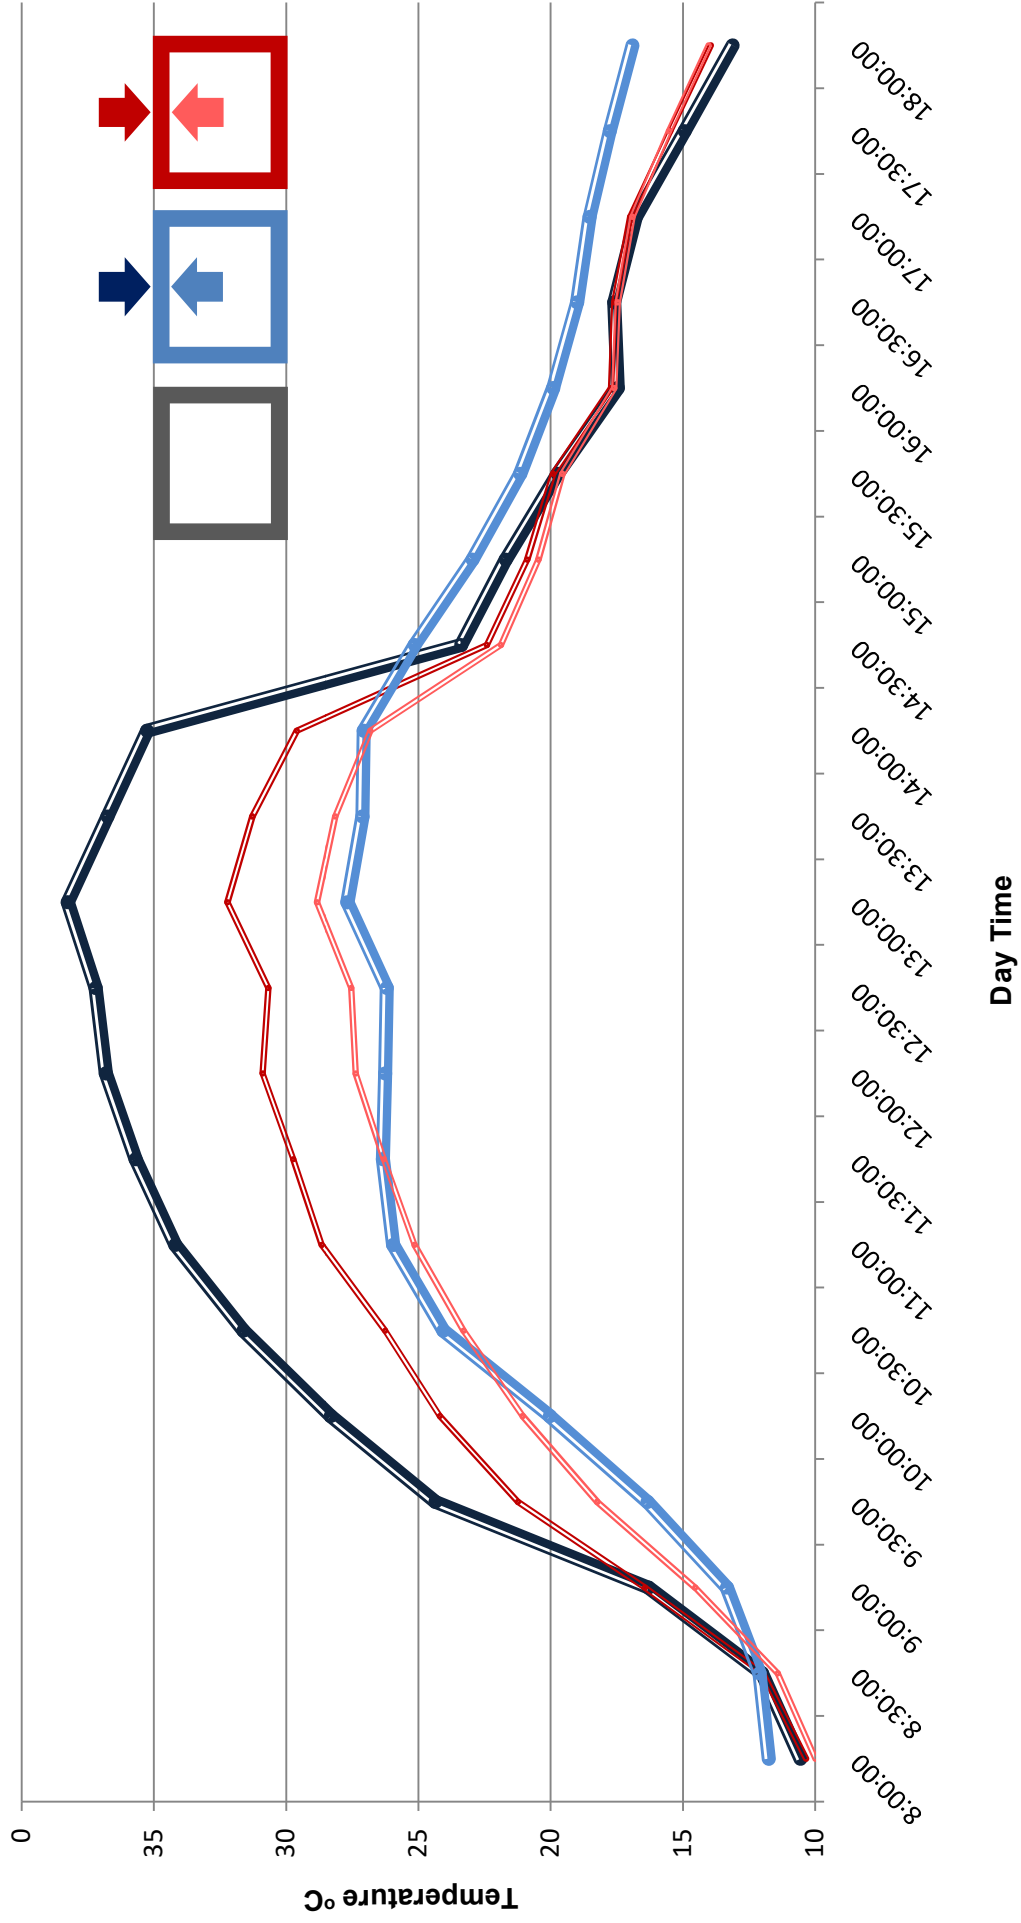
**Graph No.3: Comparing 130mm glass wool R3.0 with 0.5mm coat of C-COAT**

- Roof with R3.0 insulation - surface temp
- Roof with R3.0 insulation - underside temp
- Roof with 0.5mm of C-COAT - surface temp
- Roof with 0.5mm of C-COAT - underside temp

### **Graph No. 3 - Comparing 130mm glass wool R3.0 with 0.5mm coat of C-COAT**

The graph compares the temperature results using standard roofing with glass wool (Test Box No. 2) and 0.5mm coat of C-COAT (Test Box No. 3).
