ACRYLIC TECHNOLOGIES AUSTRALIA

C-COAT TEMPERATURE TESTING

REF: TIATA002

Trackie Industries recently carried out temperature data logging to review the performance of C-Coat surface applied thermal coating.

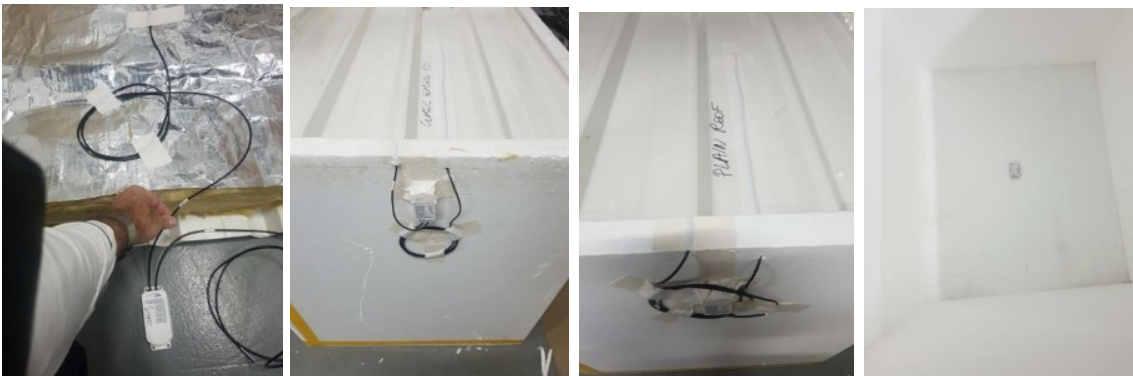
TIATA001

The temperature data was collected and tabulated as per the 2 tables below.

| Temperature testing: Plain roof, R3 130mm glass wool insulated roof and C-Coat 0.5mm applied to the top side. | | | | | | | | | | |

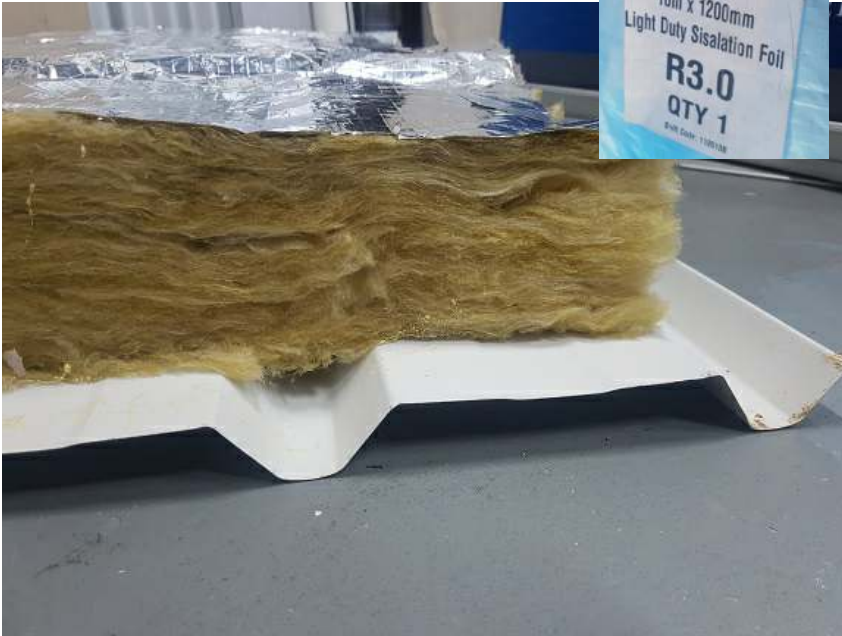
Roof with 130mm classic insulation R3.0 underside

Sensors were positioned on top of the roofs and directly underneath.

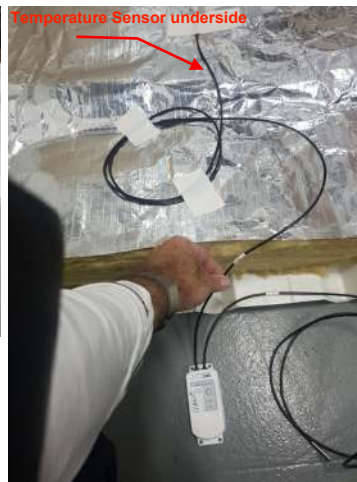
Roof with 130mm insulation R3.0

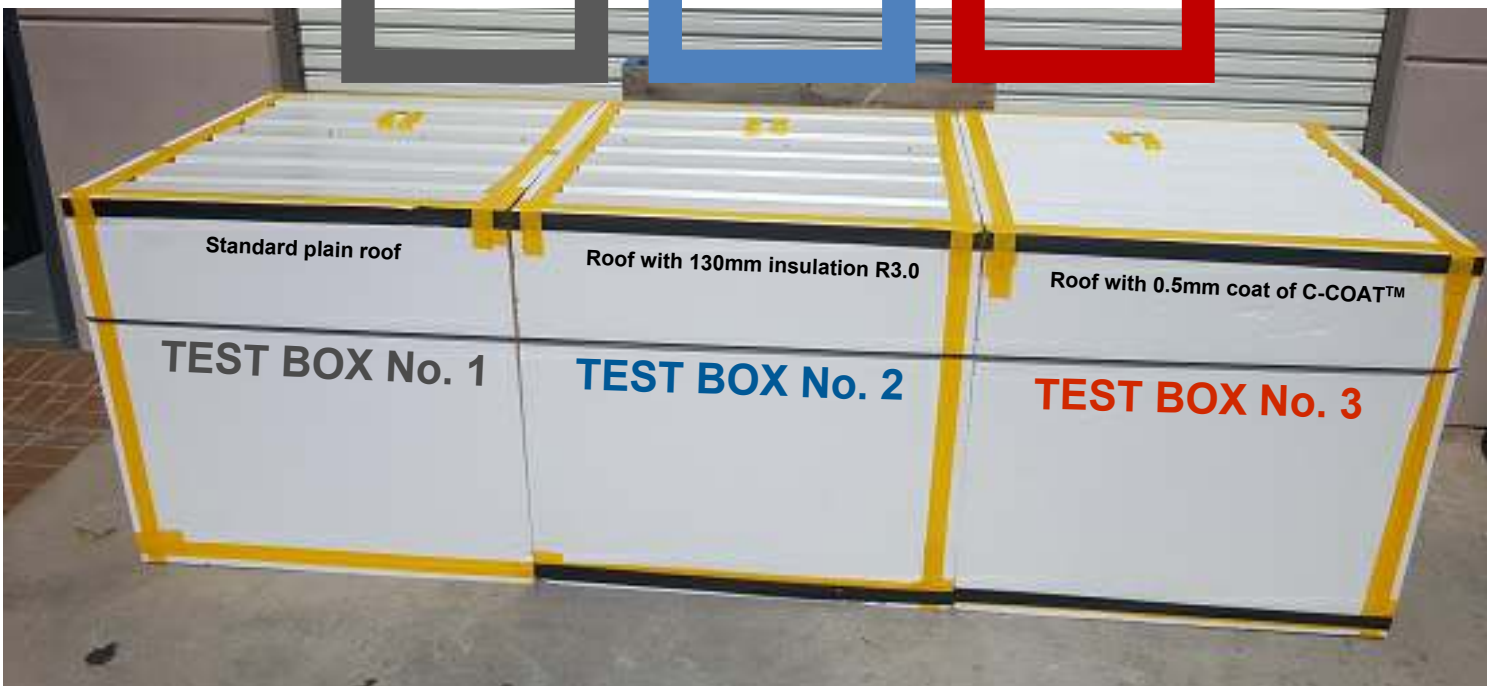
Graphic symbols used to represent individual Test Boxes in graphs

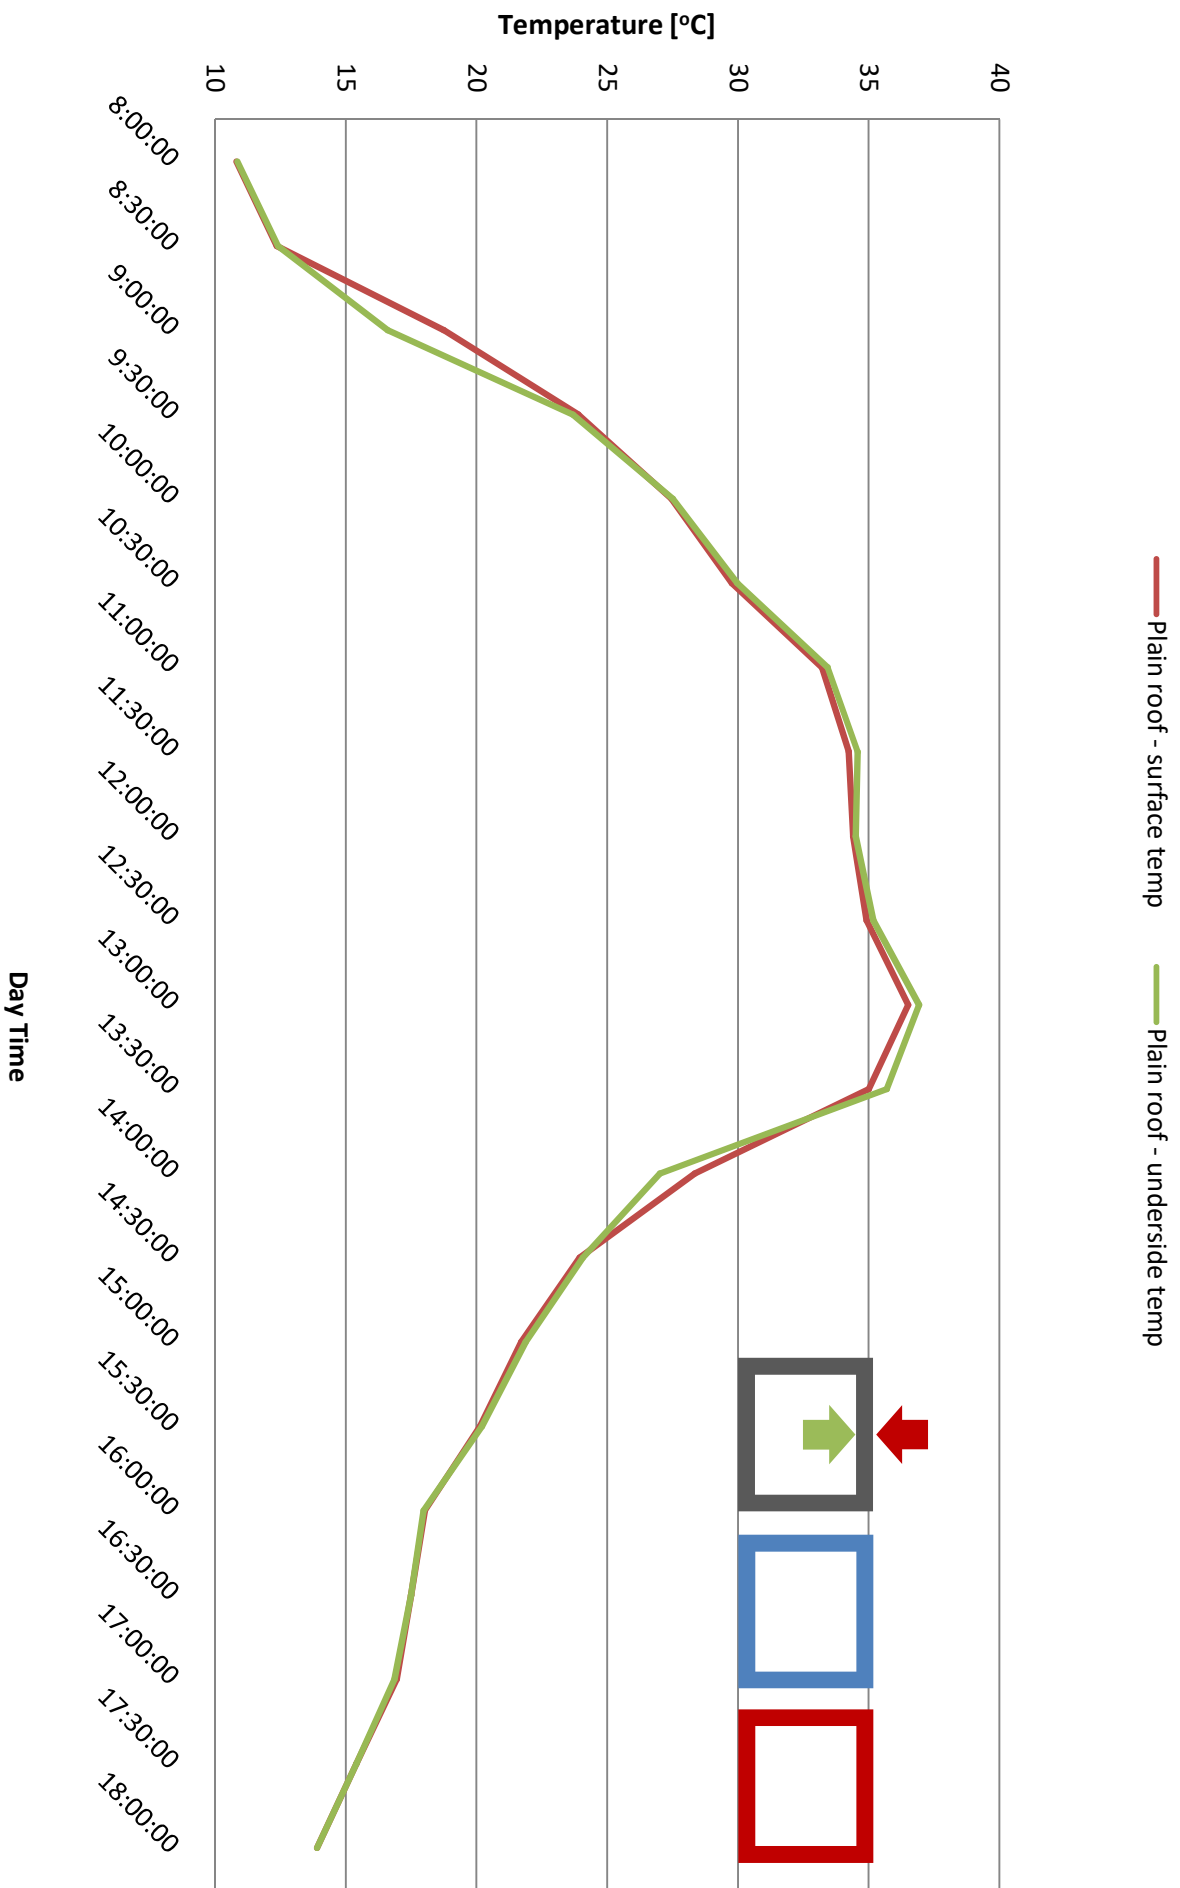
Graph No. 2: Plain Roof Temperature

Graph No. 2 - Plain Roof Temperature

This graph shows the temperature results of Test Box No.1 using standard roofing that is untreated and uninsulated. These results should be used as the base reference to compare the different insulation mediums.

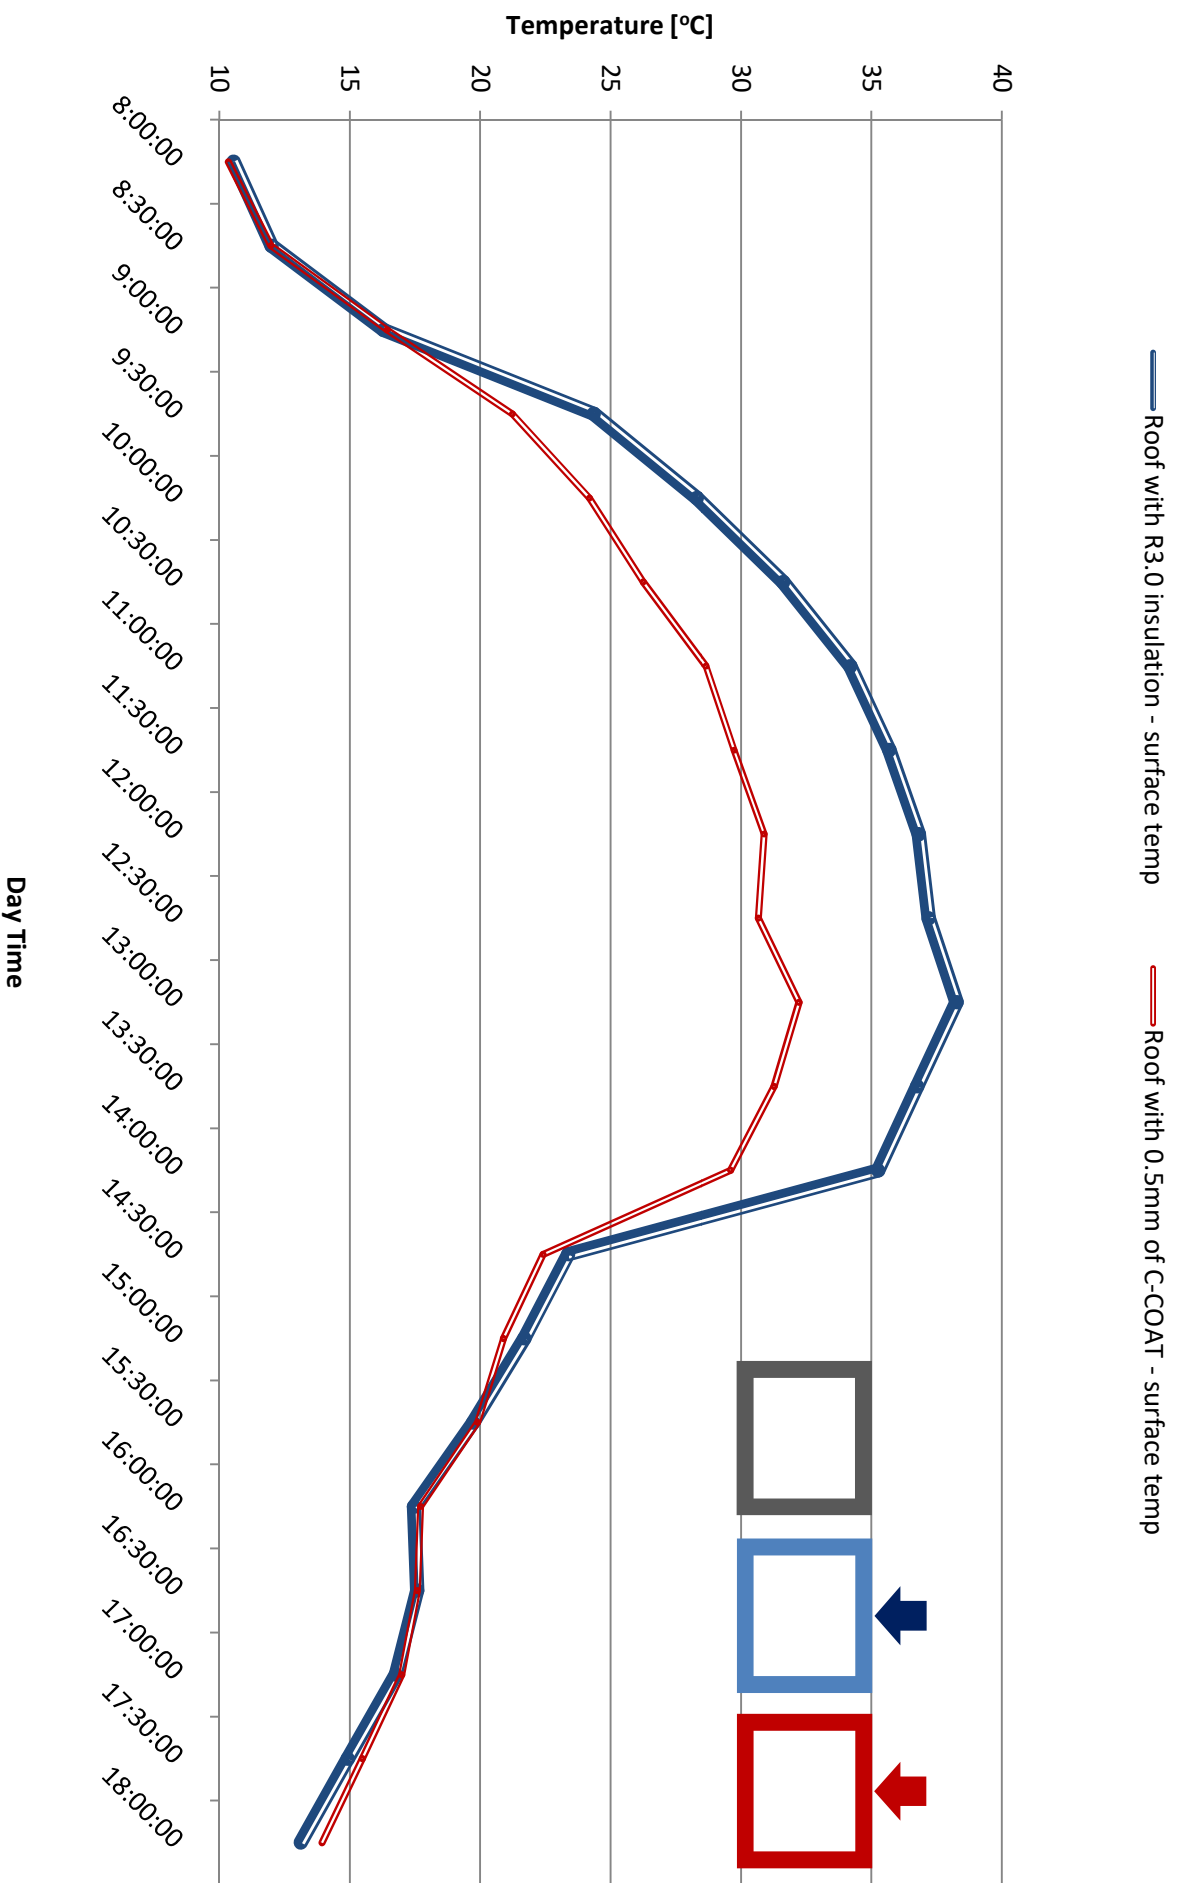
Graph No.6: Comparing 130mm glass wool R3.0 with 0.5mm coat of C-COAT

Graph No. 6 - Comparing surface temperatures of 130mm glass-wool R3.0 with 0.5mm coat of C-COAT

This graph compares the surface temperatures of Test Box No. 2 and Test Box No. 3 and clearly shows that C-COAT has significantly lower surface temperature than with glass wool insulated, indicating that heat energy has been effectively reflected.

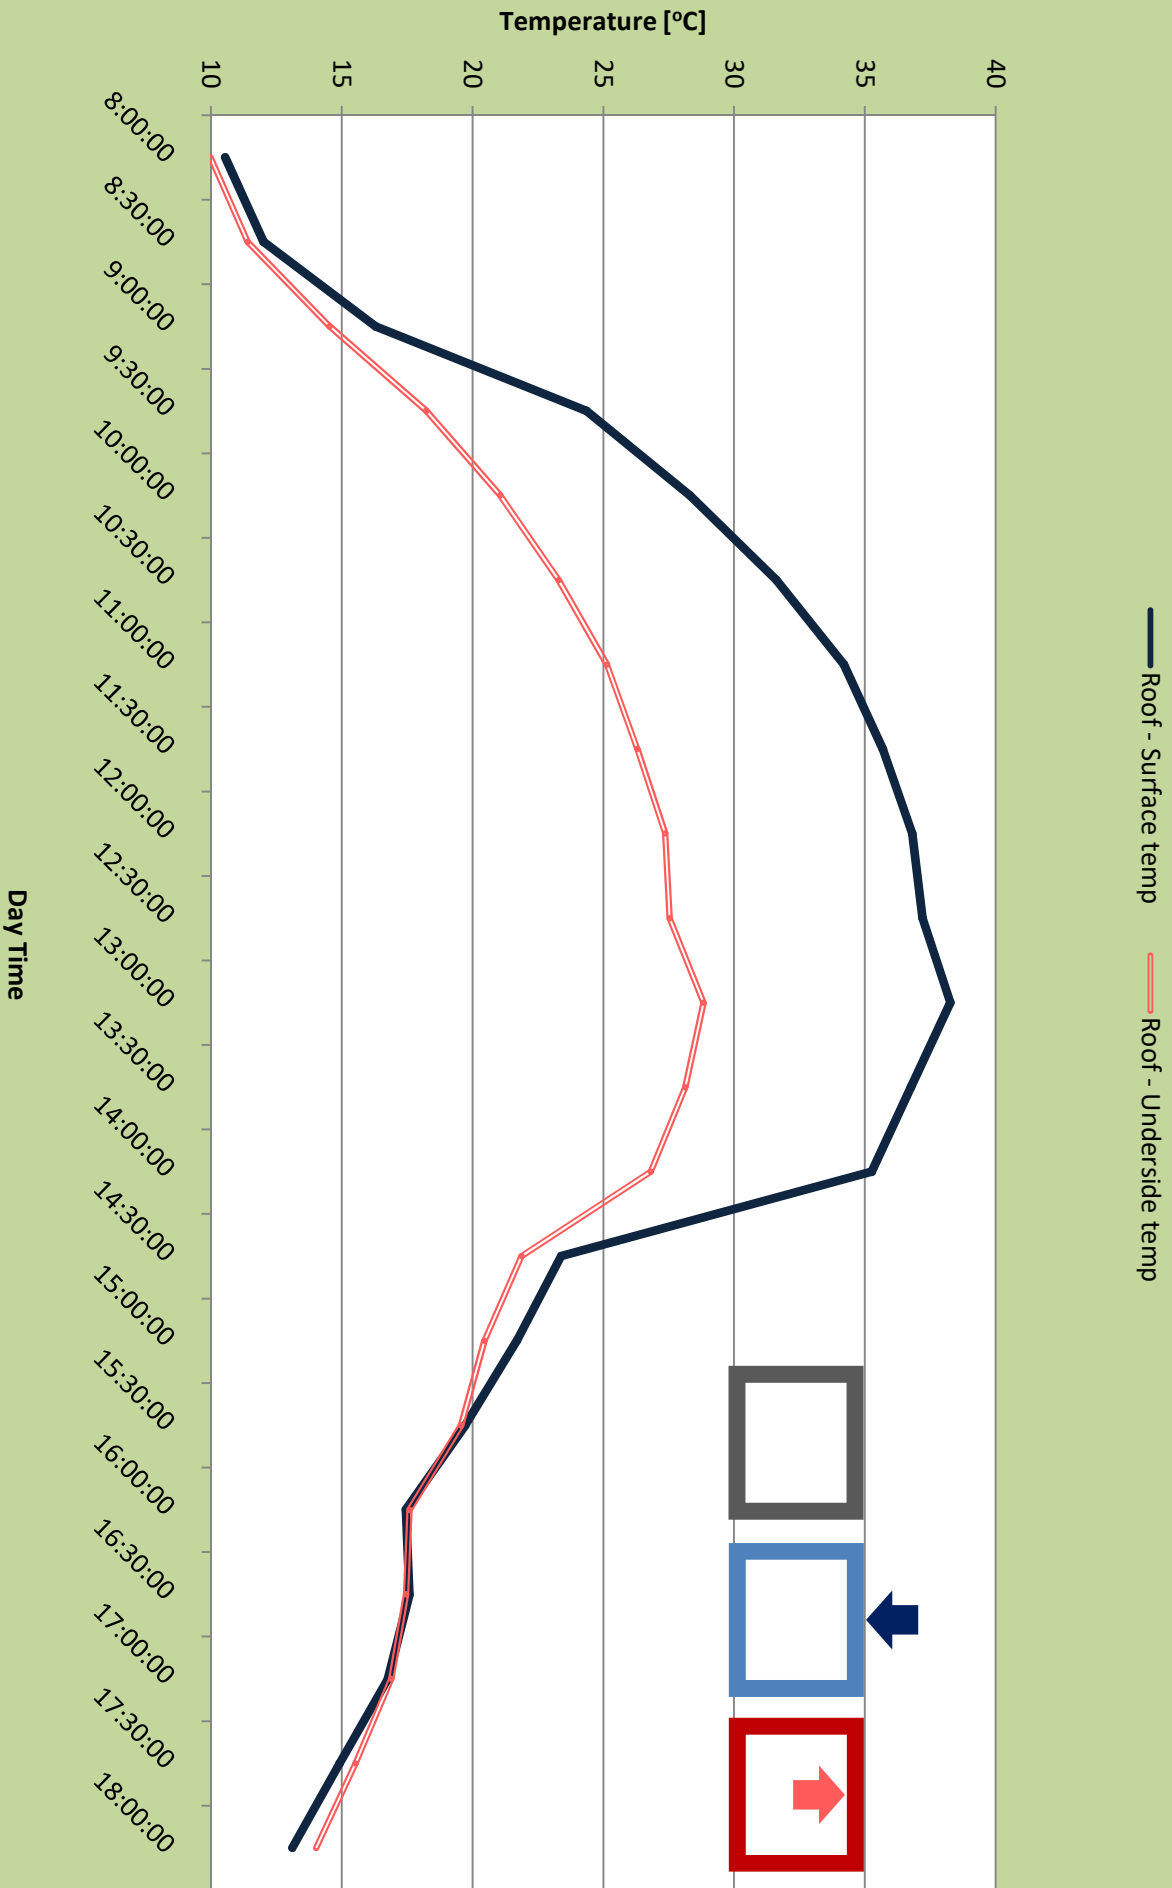
Graph No. 8: Overall reduction of temperature when 0.5mm of C-COAT is applied

Graph No. 8 - TEST SUMMARY – Overall reduction of temperature when 0.5mm of C-COAT is applied

The graph presents the temperature difference of surface temperature of Test Box No. 2 and underside temperatures inside of Test Box No. 3

These are actual temperature effects (reduction from 5°C to 10°C) achieved when 0.5mm coat of C-COAT is applied over the standard metal roof of the building while having ambient temperature from 11°C to 31°C
